Soils and Foundations

# The damage to hillside embankments in Sendai city during The 2011 off the Pacific Coast of Tohoku Earthquake

Tomohiro Mori<sup>a,\*</sup>, Yoshio Tobita<sup>b</sup>, Takashi Okimura<sup>c</sup>

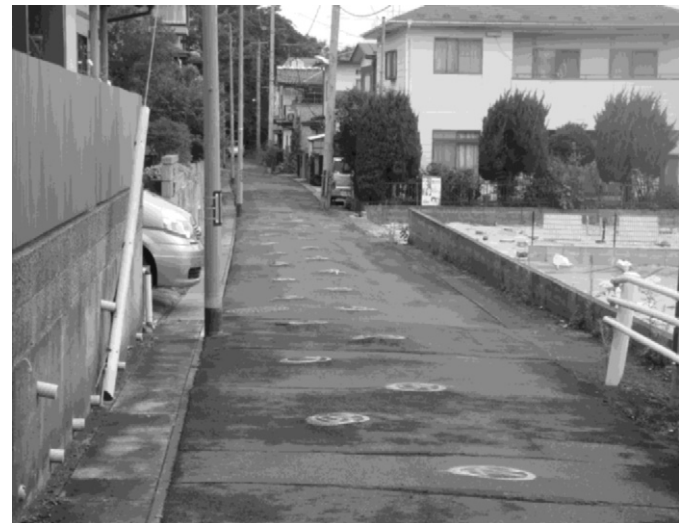
Photo 1. Exposed Piles after the 2011 earthquake (Midorigaoka-3-choume).

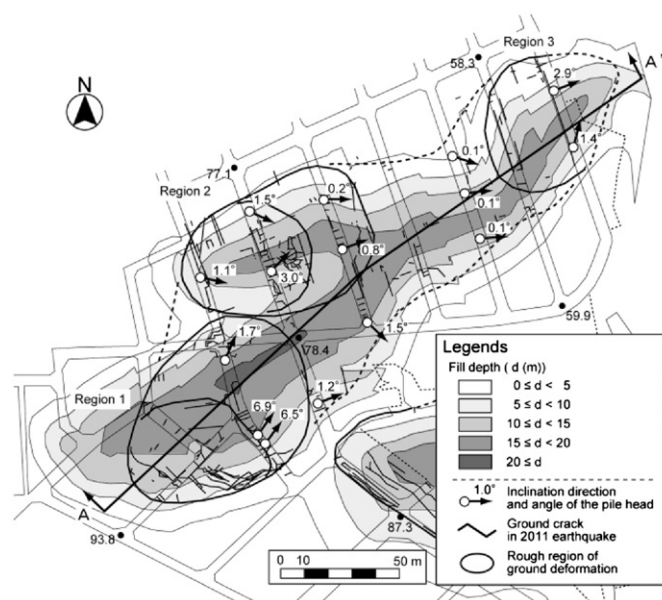
Figs. 7 and 8 show the plan and cross-sectional views of the damaged areas, the outline of the damage, and the arrangements of the piles and wells. There are two relatively narrow valley filled embankments in the land. The fill materials are composed of sandy soil with gravel and cohesive soil with gravel. The cohesive soil used for the creation of the hillside embankment is rather poor, since they contain large amounts of fine particles. No clear transition between them was observed: instead they were filled in a mixed way. The range of severe ground displacements (shallow slips and subsidence) and the distribution of surface cracks are shown in Fig. 7. The movement and the angles of inclination at the top of restraining piles are also shown in Fig. 7. Since sand boils were observed by the residents, liquefaction induced displacement is also supposed to have had an effects on the damage. The drainage from the embankment using the two groundwater drainage wells apparently was working well, with the lower level of the water table kept at –13 m to –15 m from the ground surface. The restraining piles which were fractured during the 2011 earthquake were also effective to prevent a landslide type of movement from occurring. Both countermeasures appear to have performed well during the 2011 earthquake; nevertheless, the damage incurred to houses on the housing lots on the valley filled embankment was almost equivalent to the damage during the 1978 earthquake. The severity of the damage during the 2011 earthquake to Midorigaoka 3 choume, which had been reinforced with wells and piles,

Fig. 7. Plan view on ground damages of Midorigaoka-3-choume in 2011.

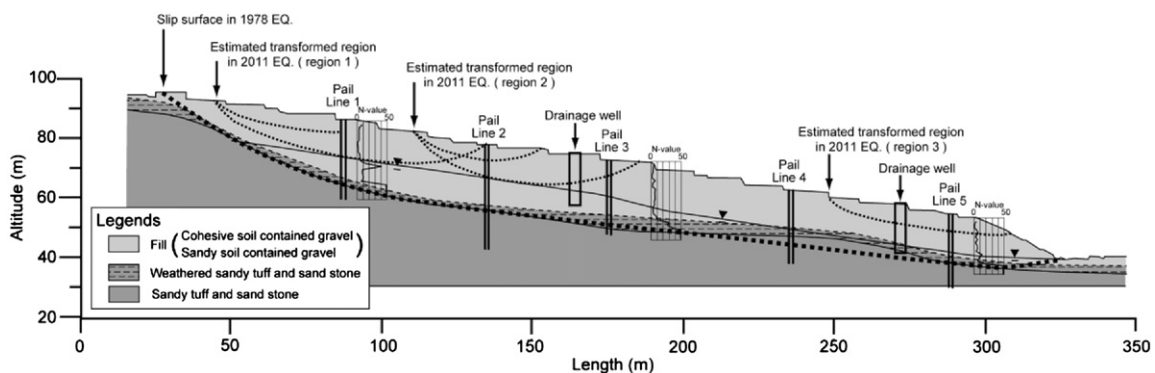
Fig. 8. Cross section view of Midorigaoka-3-choume along A–A' in Fig. 7.

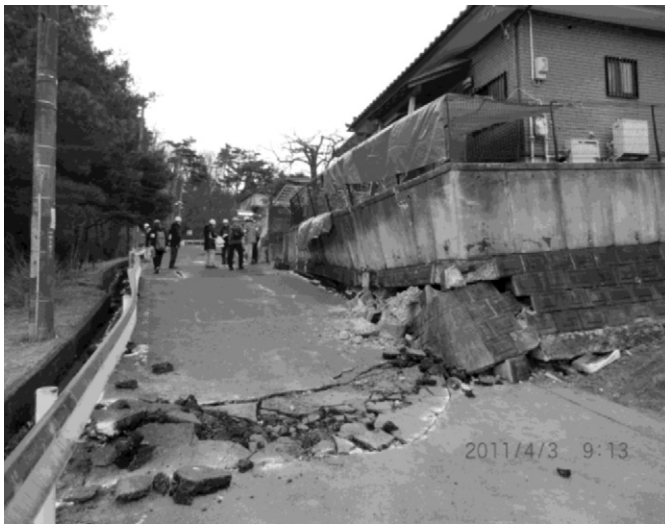
Photo 2 shows the displacements at the tip of the damaged area. The clearly damaged areas and undamaged areas are clearly distinguished by the major cracks crossing the road, the near side (supposed to be “cut” part of the original ground) from the cracks appears to show no damage, while the far side from the crack was severely damaged. The fill embankment was severely damaged, the

bulging of pavements showing the occurrence of compressive buckling, the walls set up on the top of poorly created retaining walls slid and tilted toward to the road amounting to 1.0 m. Photo 3 shows the view taken from the crest to the center of the damaged valley fill embankment. Many cracks broke the road into small pieces. These cracks suggest that a valley filled with cohesive soils was displaced severely due to seismic motions, in particular at the shallow part of the embankment. The depth of ground displacements in the fill embankment was estimated to be shallow; the elastic wave exploration indicated that the depth of displacement was about  $-5.0$  m at the center and  $-7.0$  m at the tip of the damaged area.

It is worthwhile noting from these observations that the severe damage to housing and housing lots at this site can be primarily attributed to the severe ground displacement of weak fill materials near the surface; the damage was the consequences of shallow slip movements, many cracks, and differential settlements. Since a large landslide type failure is also expected at this site, attention should also be

Photo 2. Ground displacement at tip of damaged area (Oritate-5-choue).

paid to the selection of countermeasures which could prevent a large landslide type failure event from occurring.

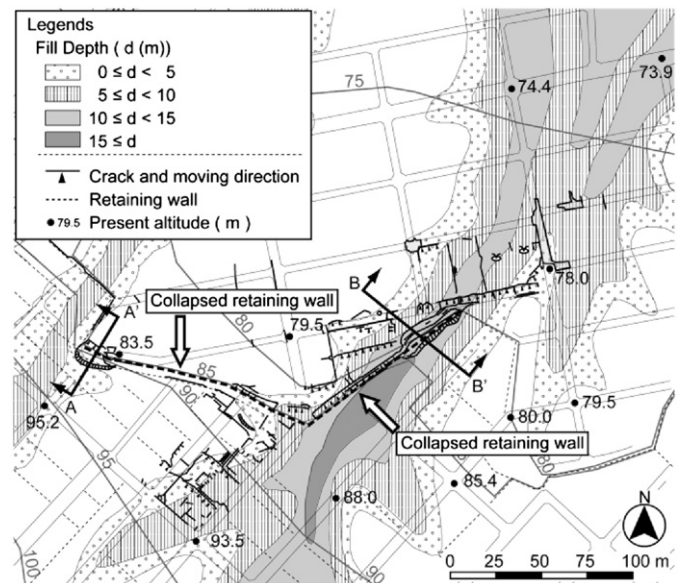
Fig. 11. Plan view of Takimichi area.

Fig. 11 shows the location of the damaged retaining walls, associated cracks, and the fill depth. With regard to the location of the fill and cut boundary with relation to the cracks, a large number of cracks appeared on the fill part, in particular on the fill part adjacent to the boundary between fill and cut.

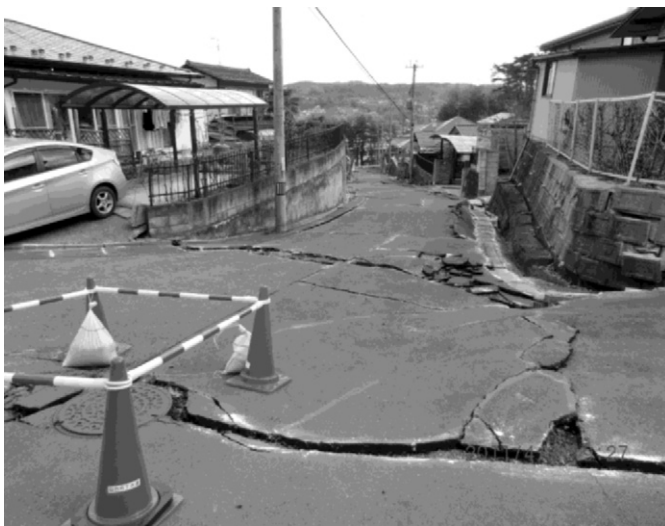
Photo 3. View from the crest of damaged valley fill embankment (Oritate-5-choue).

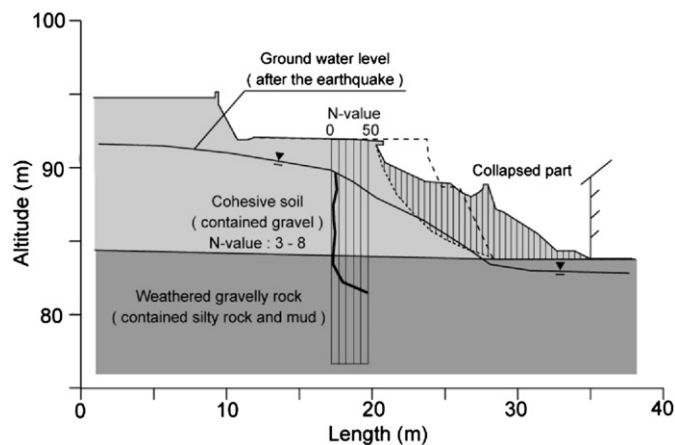
The damaged retaining wall to the west was set up on the cut side, as seen in the cross section view shown in Fig. 12. The retaining wall was 8.0 m and constructed in 2 stairs, with a foundation composed of weathered gravel rock. The backfill materials were composed of cohesive soil with gravel with SPT  $N$  values were from 3 to 8. The groundwater table at the onset of the 2011 earthquake was estimated to be shallow. There was no apparent ground displacement on the lower ground surface adjacent to the retaining walls, with ground displacement occurring only in the backfill. The complete failure of the retaining wall set up on the cut part in the west direction can probably be

Fig. 12. Cross section view of Takimichi area along A–A' in Fig. 11.

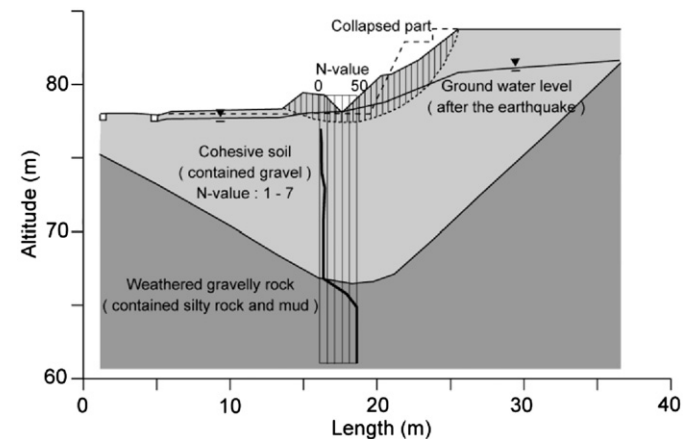
Fig. 13 shows the cross section view along the line B–B' (which is located in the northeast direction). The backfill materials were composed of cohesive soils containing gravel, with SPT  $N$ -values from 0 to 7. The bulging of the lower ground surface was evidence of the occurrence of circular slip movement (see Photo 5). The failure of the retaining walls on the northeast direction appeared to be associated with the failure of the ground. Around the damaged retaining walls, there were several indications of ground displacement, such as the bulging of retaining wall, horizontal slips and the bulging of the base foundations.

Fig. 13. Cross section view of Takimichi area along B–B' in Fig. 11.

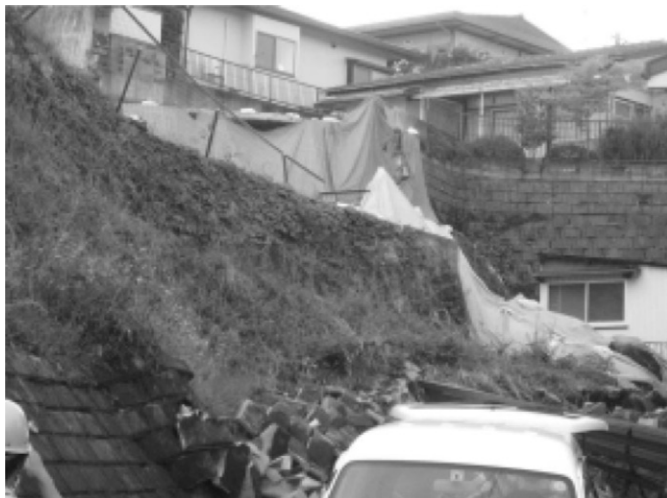
attributed to the inertia force due to the seismic motion; however the use of cohesive soils as backfills and the shallow groundwater table played certainly an important role in the failure (see Photo 4).

Photo 4. Failure of retaining wall in the west direction (Takimichi).

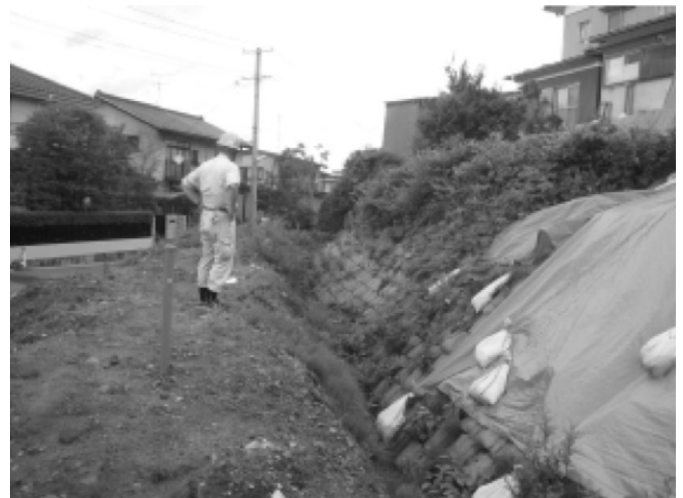
Photo 5. Circular slip movement in the northeast direction (Takimichi).

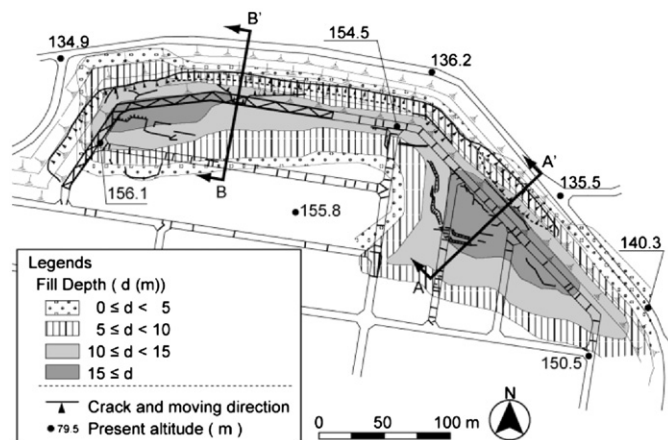
Fig. 14. Plan view of Takanohara-2-choume.

Fig. 14 shows a plan view of this site, with the location of damages and the fill depth also shown. The residential land was created by cutting the central part of the hills and filling the surrounding lower area. This site has irregularly distributed valley filled embankments and partially filled embankments at the outer part of the land, which reflects the original topography. The east and west sides of the damaged area were a valley filled and a partially filled embankments respectively, with a maximum fill depth of 17 m. Many open cracks due to tension force appeared along the roads located at the top of slope surrounding the lands. Displacement due to bulging appeared mid-slope. Field observation indicated that the top of the slope was shaken severely by the strong seismic motion.

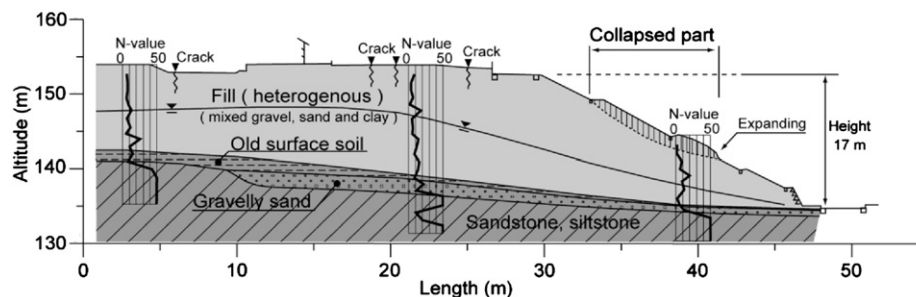
Fig. 15 shows the cross section of the damaged embankment on the east side (along the A–A' line in Fig. 14). A fill embankment amounting to 17 m in height was created on a bedrock of sand stone or silt stone. The fill materials were composed of gravel, sand, and clay, and different soils were filled in an irregular way. The SPT *N* values showed a wide scatter from 1 to 20. The groundwater tables were deep overall and that at the mid-part of the damaged slope was kept at  $-7.0$  m. In this cross-section, shallow displacement appeared on the mid-slope of the embankment and bulging occurred on the bottom. Many cracks also appeared on the flat part of the residential land; however, no interaction with the displacements of the slopes was supposed. Fig. 16 shows the cross section of the damage at the west side of the land. The displacement which appeared from the mid-part to the top of the slopes suggests slip type movement, and bulging occurred at the bottom. By comparing the two sections shown in Figs. 15

Fig. 15. Cross section view of Takanohara-2choume along A–A' in Fig. 14.

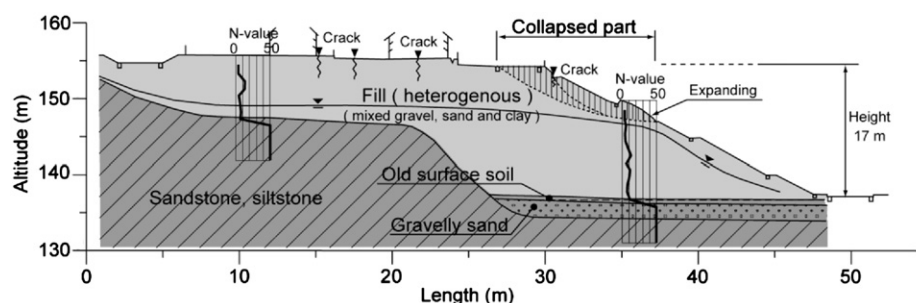
Fig. 16. Cross section view of Takanohara-2choume along B–B' in Fig. 14.

and 16, we may note that the water table along B–B' was remarkably shallow, with the bottom part just  $-1.0$  below the surface; while the water level at the A–A' section was deep. The difference in the groundwater table may have partly attributed to the different soil properties.

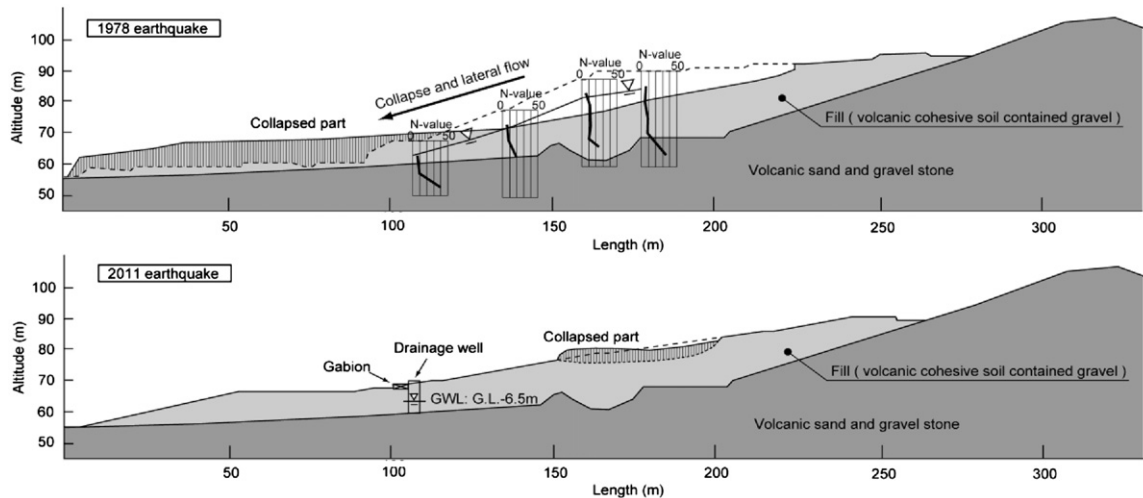
Fig. 18 shows the cross sections of the damaged fill embankment after the 1978 earthquake along the line A–A' in Fig. 17. The fill depth amounted to 25 m at the top of the slope and the maximum slope angle was 23°. The shallow groundwater table was partly due to filling over a pond. After the collapse as the result of the 1978 earthquake, the fill embankment was re-filled with a slope angle of 10° with a drainage system consisting of a stone filled net and two water collection wells constructed at the

Fig. 18. Comparison of cross section views between the 1978 earthquake and the 2011 earthquake along A–A' in Fig. 17.

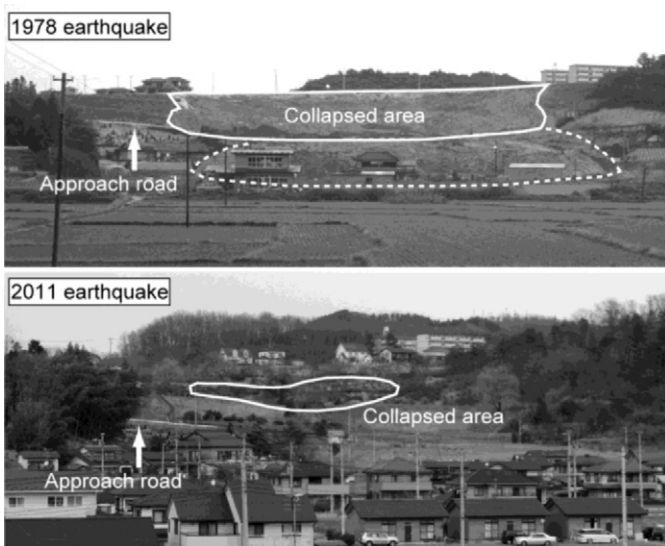
Photo 6. Comparison of collapsed area after the 1978 earthquake with that after the 2011 earthquake (Midorigaoka residential land (Kotobukiyama)).

toe of the slope in order to drain groundwater from the embankment. During the 2011 earthquake, many small slip failures with a shallow depth of at most 4 m occurred from the top to the mid-part of the embankment where the slope angle was relatively steep and no groundwater drainage system had been put in place, however, no remarkable ground displacement was observed near the toe part of the embankment, where the slope angle was gentle (about  $10^\circ$ ) and the drainage worked well. The water table at the toe part remained at  $-6.5$  m from the ground surface. Photo 6 shows the configuration of the collapsed fill embankment after the two strong earthquakes. A much smaller area collapsed area during the 2011 earthquake than during the 1978 earthquake.
